Picture of the Week

April 11, 2022

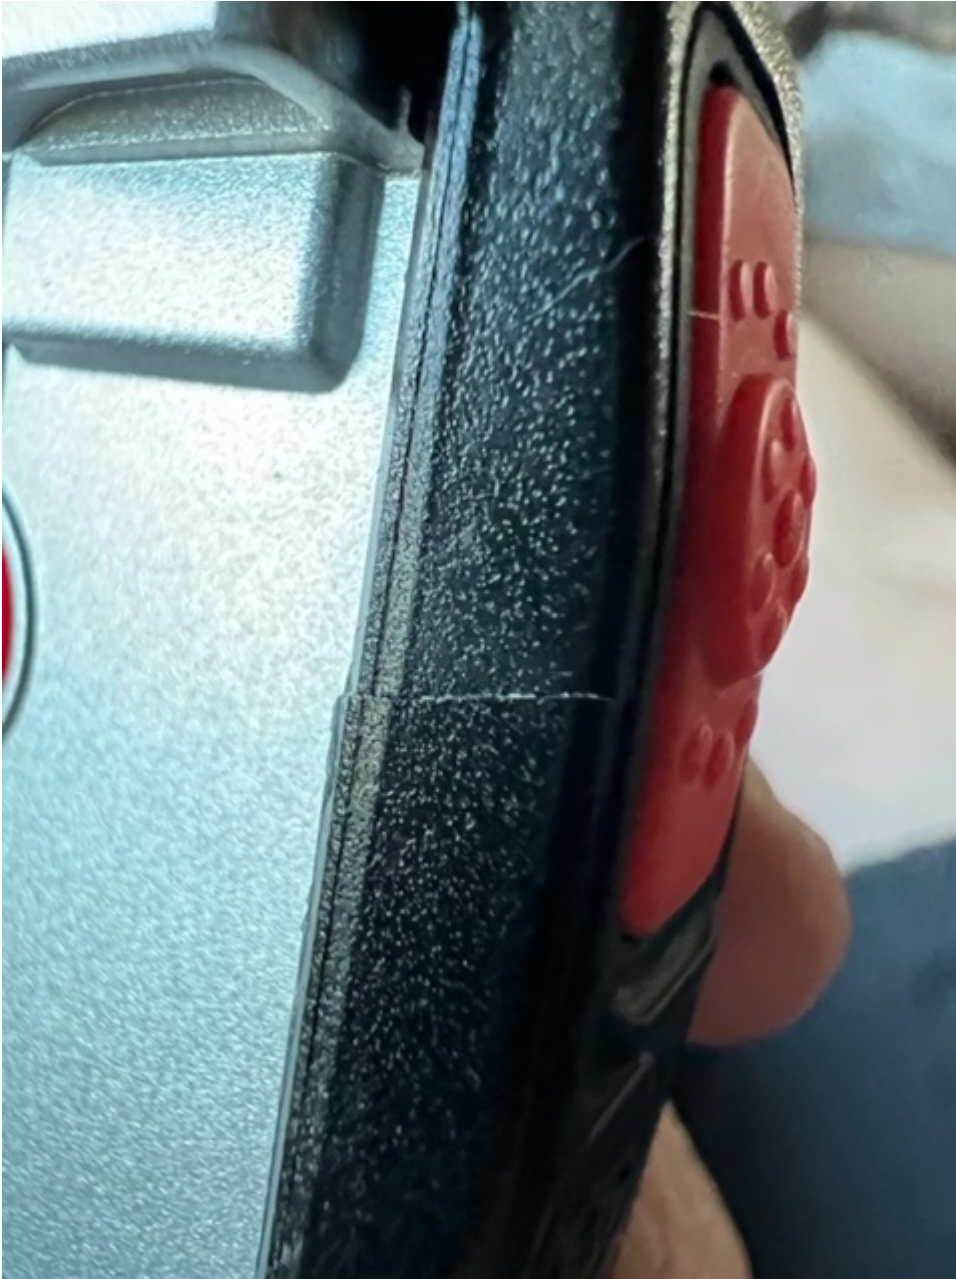
18 Jul 2022: A crack in the FT5 case. The discussion is taking place on Twitter.

Crack in FT5 case

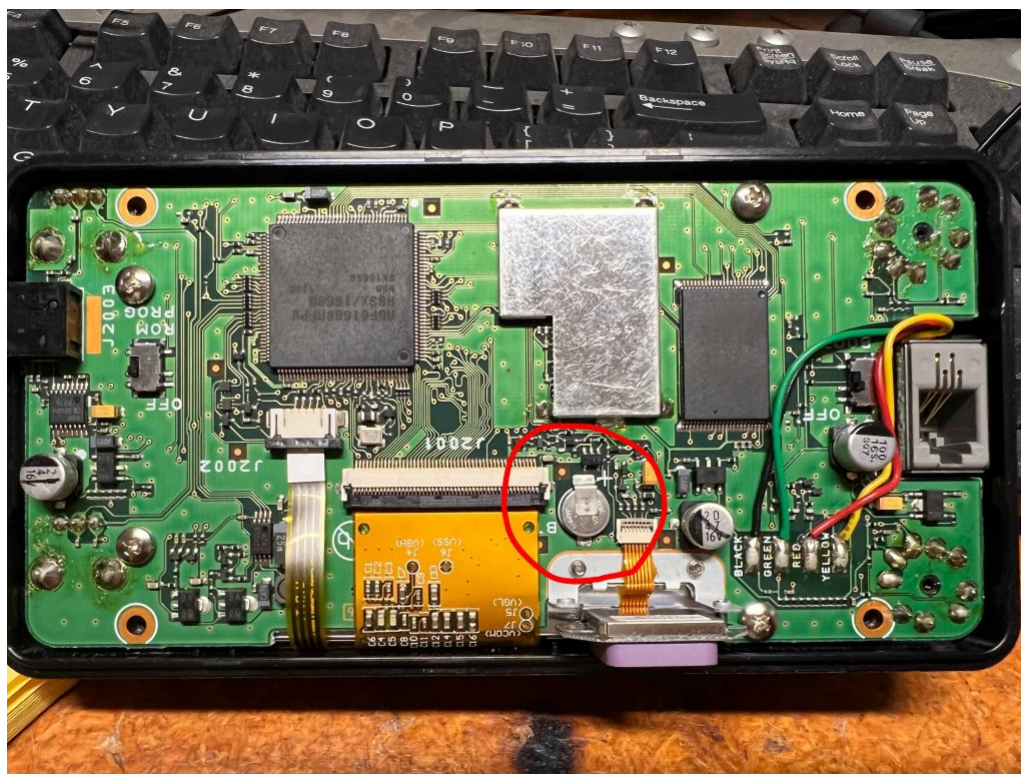
23 May 2022, photo of the board used in the FTM-400 radio. The Li-ion GPS backup-up battery is circled.
